HISTORIC STRUCTURE REPORT

HERMIT'S REST GRAND CANYON NATIONAL PARK

> Preservation Studies Program College of Architecture & Landscape Architecture The University of Arizona

December 2007

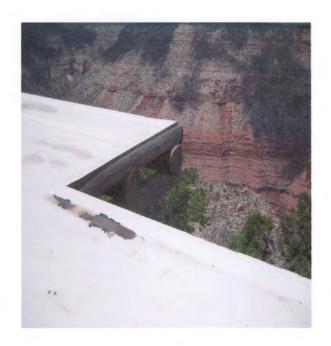
3. Roof Ponding and Failure

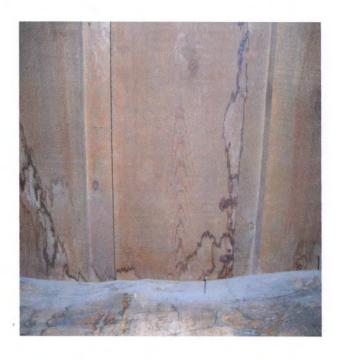
4. Ceiling Water Stain

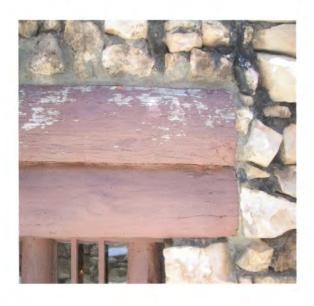
5. Paint Peeling at Clerestory Window

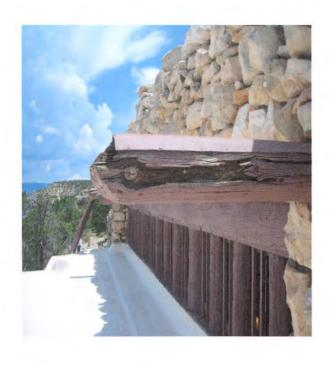
9. Outlooker - Deterioration

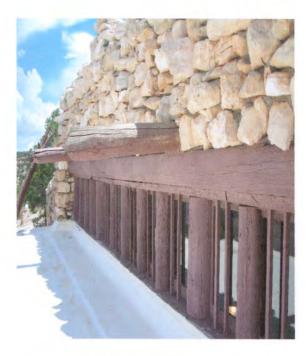
10. Outlooker - Deterioration

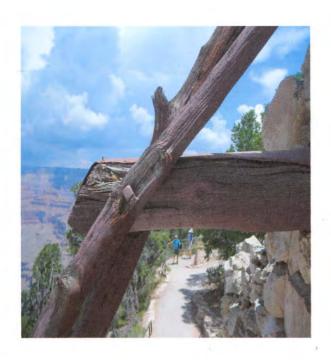
11. Outlooker - Deterioration

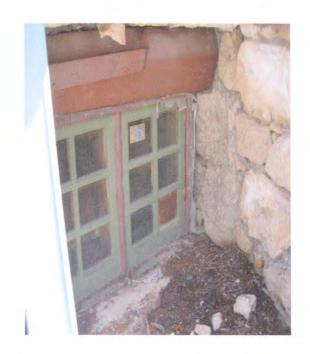
12. East Window - Poor Drainage

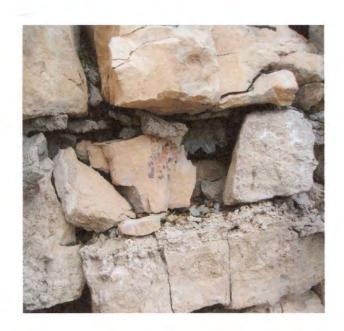
19. Voids in Retaining Wall
