HISTORIC STRUCTURE REPORT

HERMIT'S REST GRAND CANYON NATIONAL PARK

> Preservation Studies Program College of Architecture & Landscape Architecture The University of Arizona

December 2007

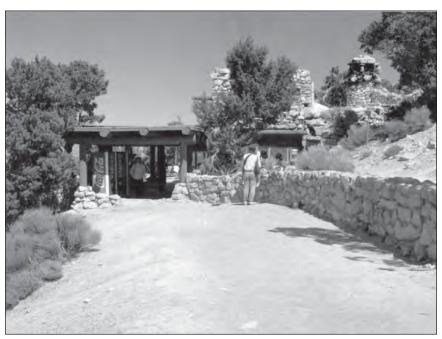
FIG. CD22: View of the Hermit's Rest facing east showing the west porch addition over the soda machines, 1988 (Source: GRCA, Museum Collection, Photograph 15918).

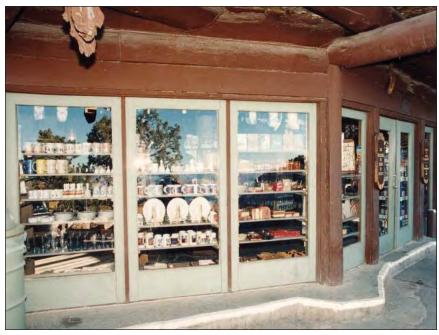
FIG. CD23: Windows blocked by merchandise display on interior, 1994 (GRCA 62427).

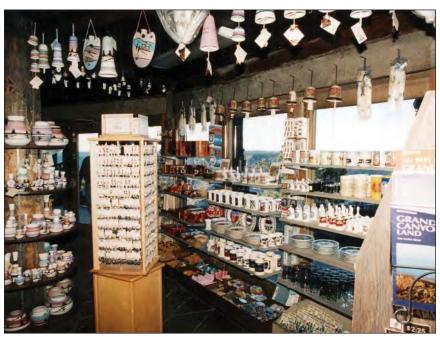
FIG. CD24: Extensive merchandise diplay around post at left and window at right, 1994 (GRCA 62427).

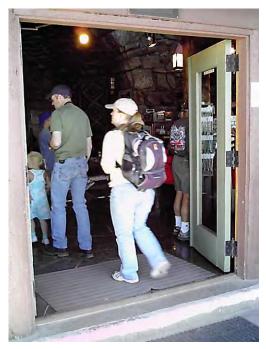
Figure 3: Main Entry doors showing landing and door swing

"Main entrance has double doors that swing inward; but doors are propped open during business hours. If doors are closed during colder months, existing doors would be required to swing out."

However, IBC section 1003.1.2 (and NFPA 101, section 7.2.1.4.2) requires doors to swing in the direction of travel (outward) *only if the occupant load is greater than 50*. As currently utilized, the building occupant load is less than 50 (44) and would therefore not require modification to the doors.

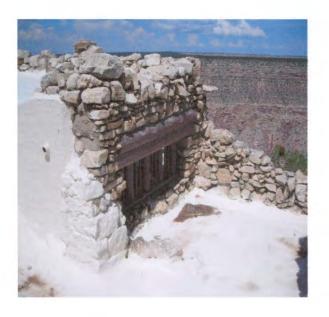
1. Roof Ponding

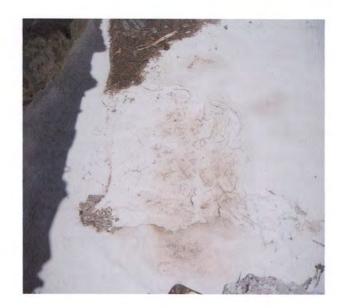
2. Roof Ponding, Rips, Wrinkles

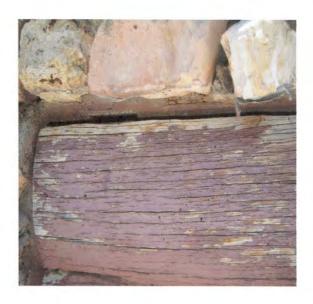
6. Separation at Lintel and Fascia

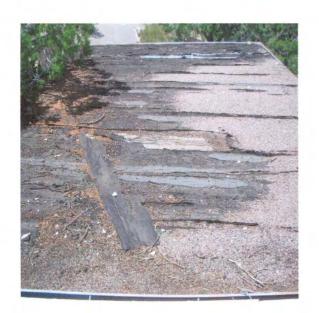
7. Patio Addition Poor Roofing

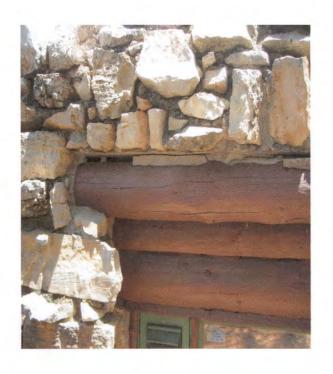
13. Lintel / Fascia Separation

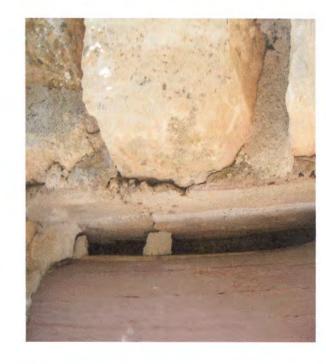
14. Close up of Separation

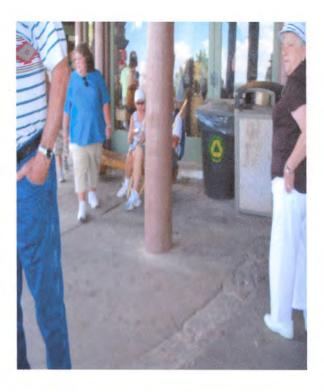
16. Porch Column Base

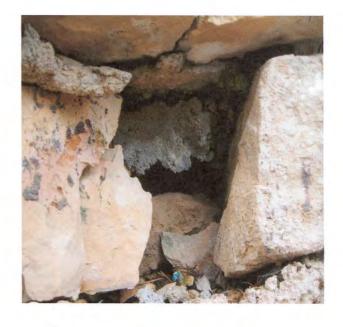
eroded at the base (refer to photo 17), has gaps and settlement in the stone work (refer to photos 18, 19, and 20), and a stone has fallen out of the wall (refer to photo 21).

20. Close up view of Voids

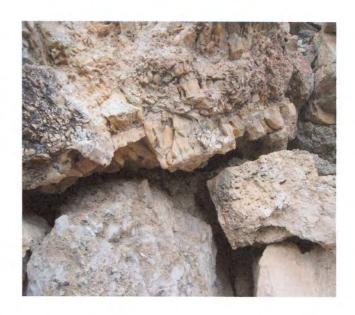
21. Stone fallen from Wall

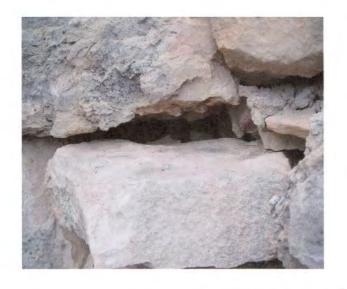
- 14. Stone Retaining Wall at front of Patio: The portion of the stone masonry retaining wall without porch roof columns bearing on it also has settlement gaps in the stone work (refer to photos 22 and 23).
- 15. Water Tank at rear of building: The water tank sits on a concrete pad. The edge of the concrete pad has been undercut and there are gaps in the stonework supporting the pad (refer to photos 25 and 26).

22. Settlement Gap in Wall

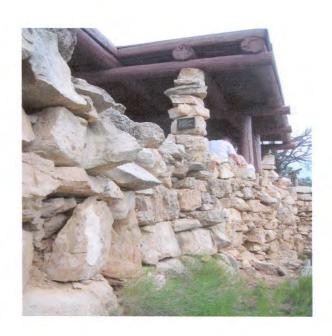
23. Settlement Gap in Wall

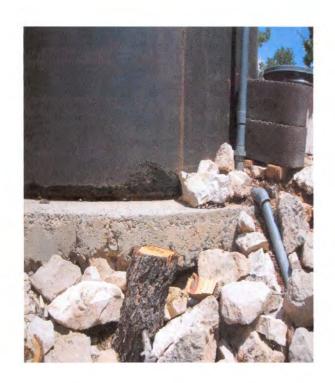
25. Water Tank - Pad undercut

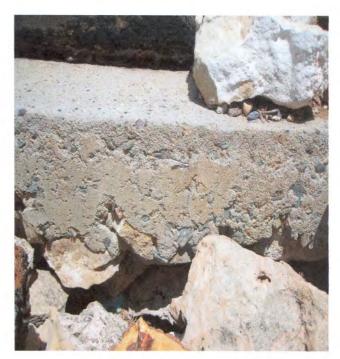
26. Close up of Pad
